Success Story

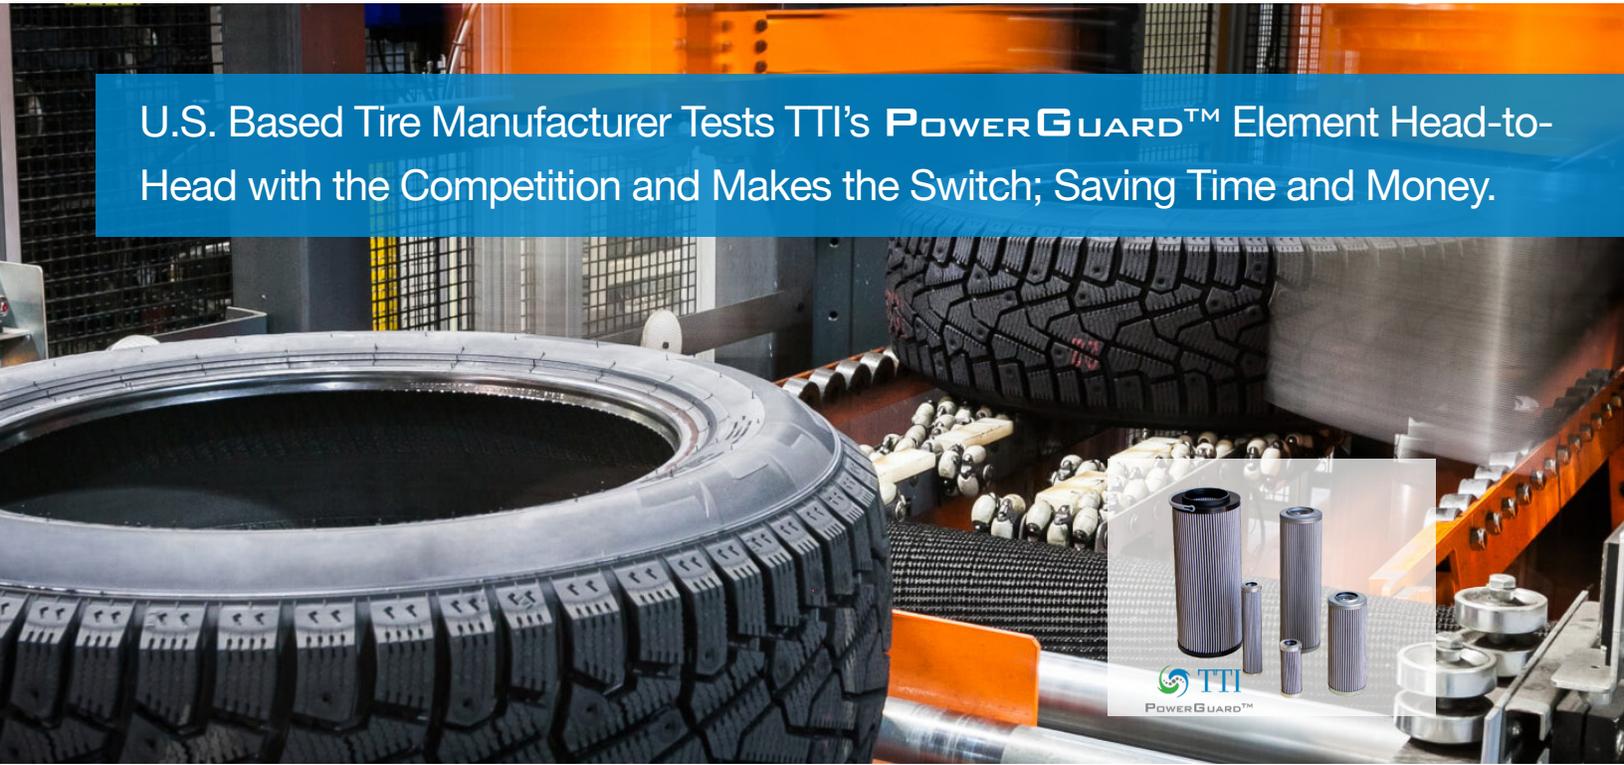
TTI TT107-36-IRV POWERGUARD™ Element

With a TT107-36-IRV PowerGuard™ filter element in hand, the maintenance professionals were ready to conduct their testing to ensure TTI's filter element met their expectations. Their method included using a portable oil analysis machine installed on a vacuum dehydrator to report ISO fluid cleanliness codes and other data points such as viscosity, temperature, and moisture. The maintenance team selected two identical, equally contaminated systems for head-to-head evaluation on the same maintenance
